Philips Consumer Lifestyle

# Service Manual

## FC8700/01 / FC8700/71

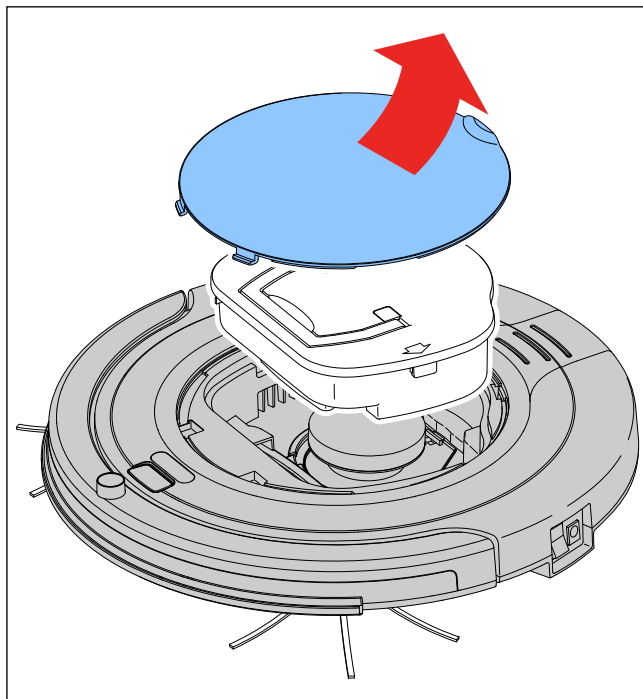
- First make sure that the appliance is unplugged.
- To empty and/or replace the Dustbin assy, the Top Cover has to be removed (see picture).

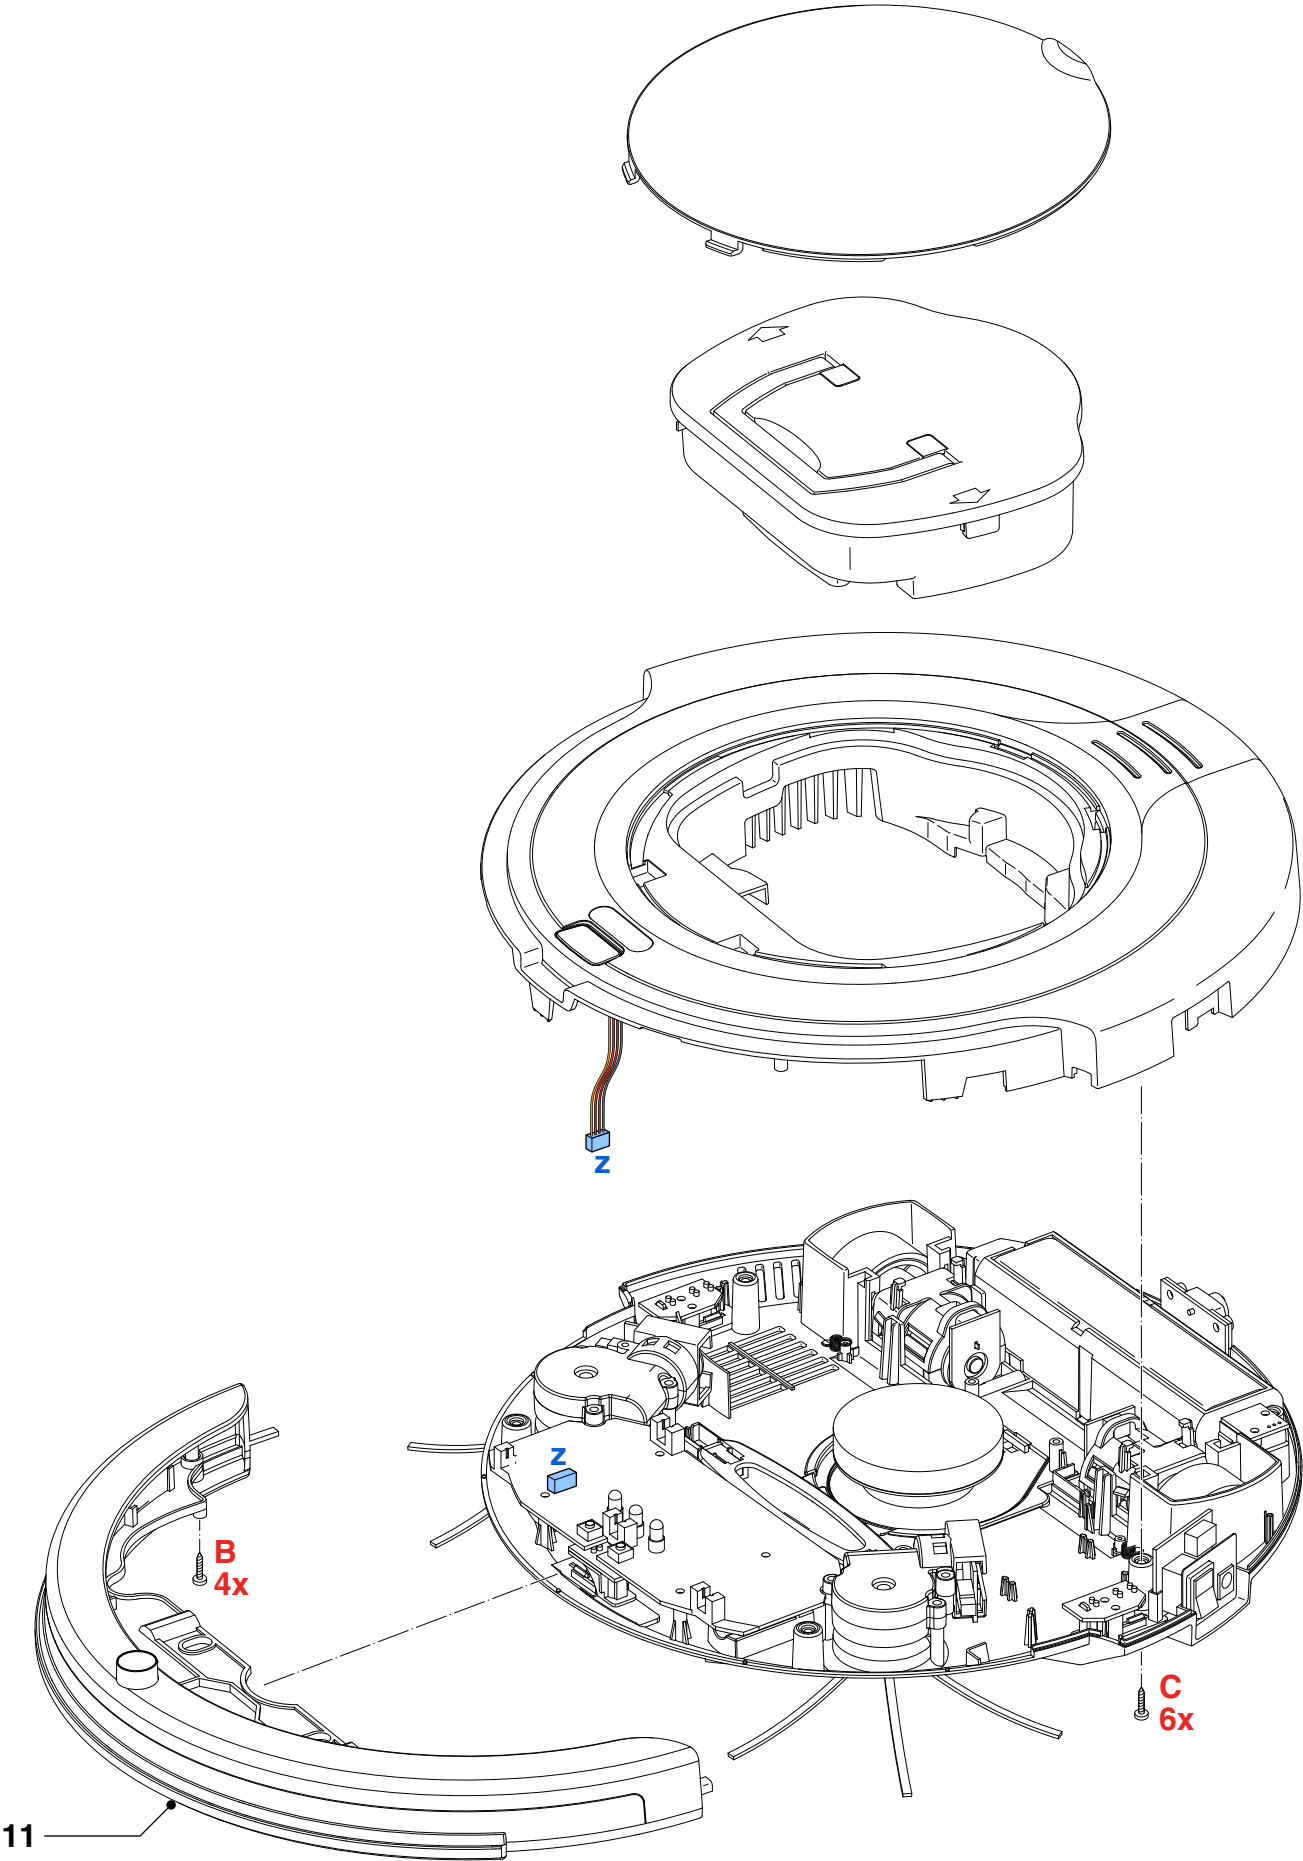
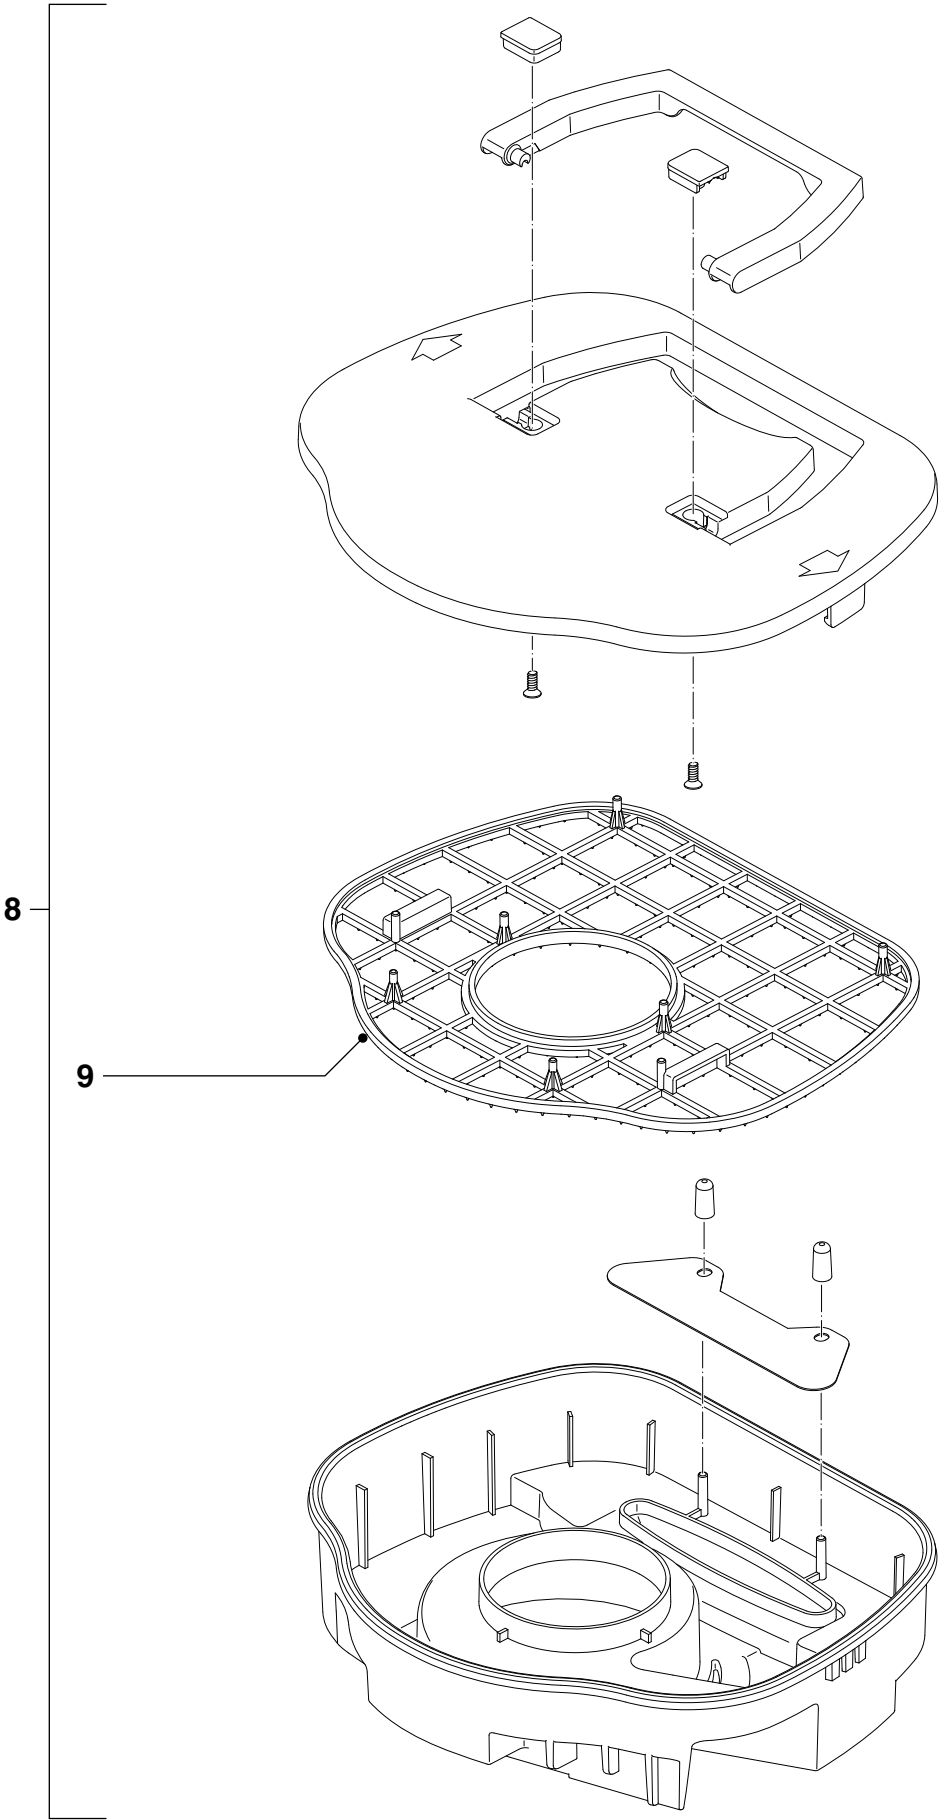
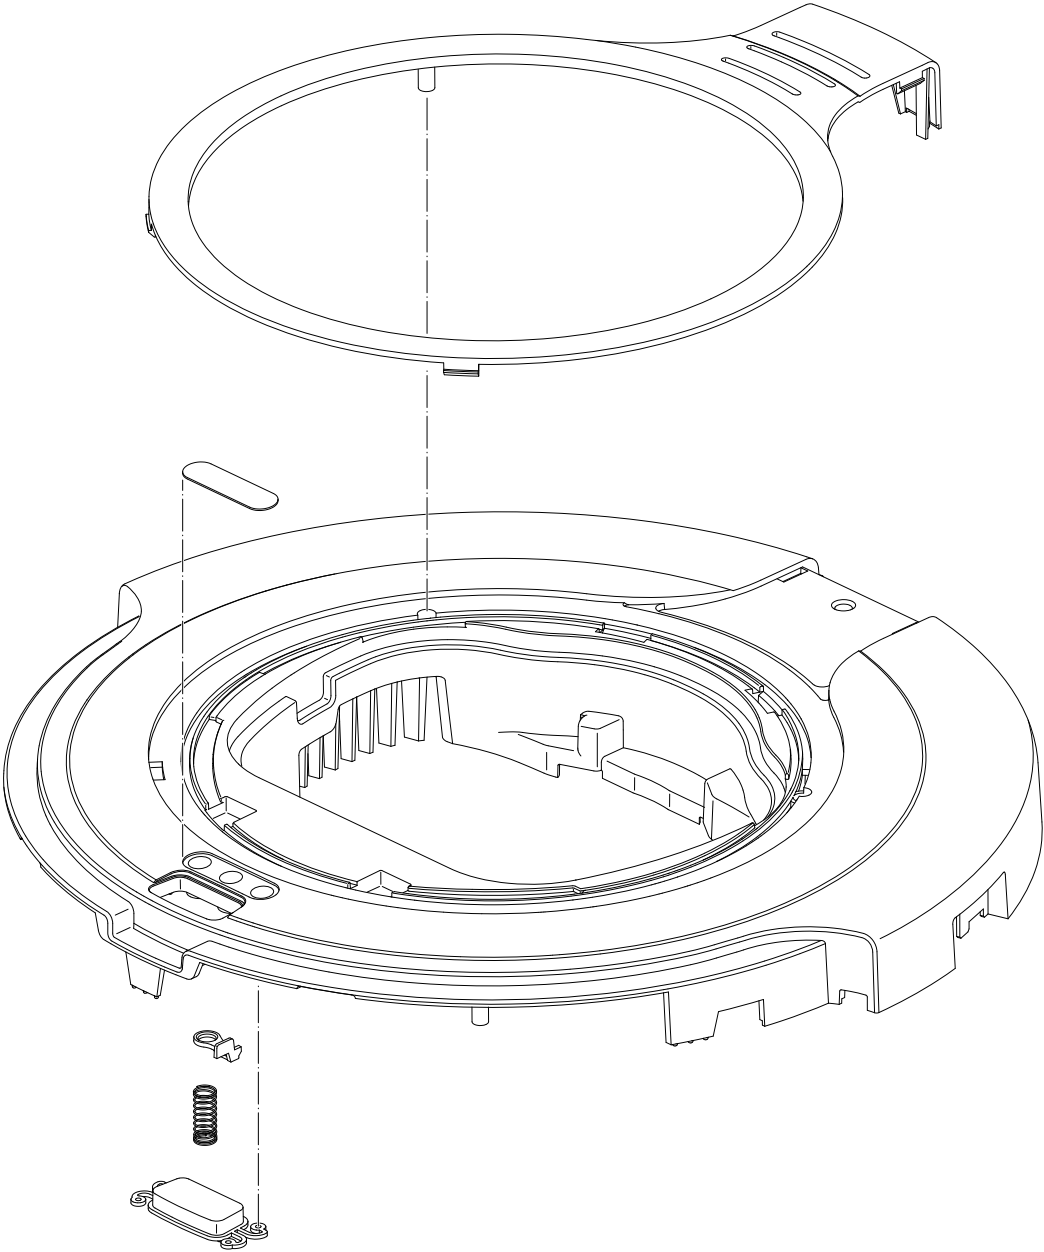
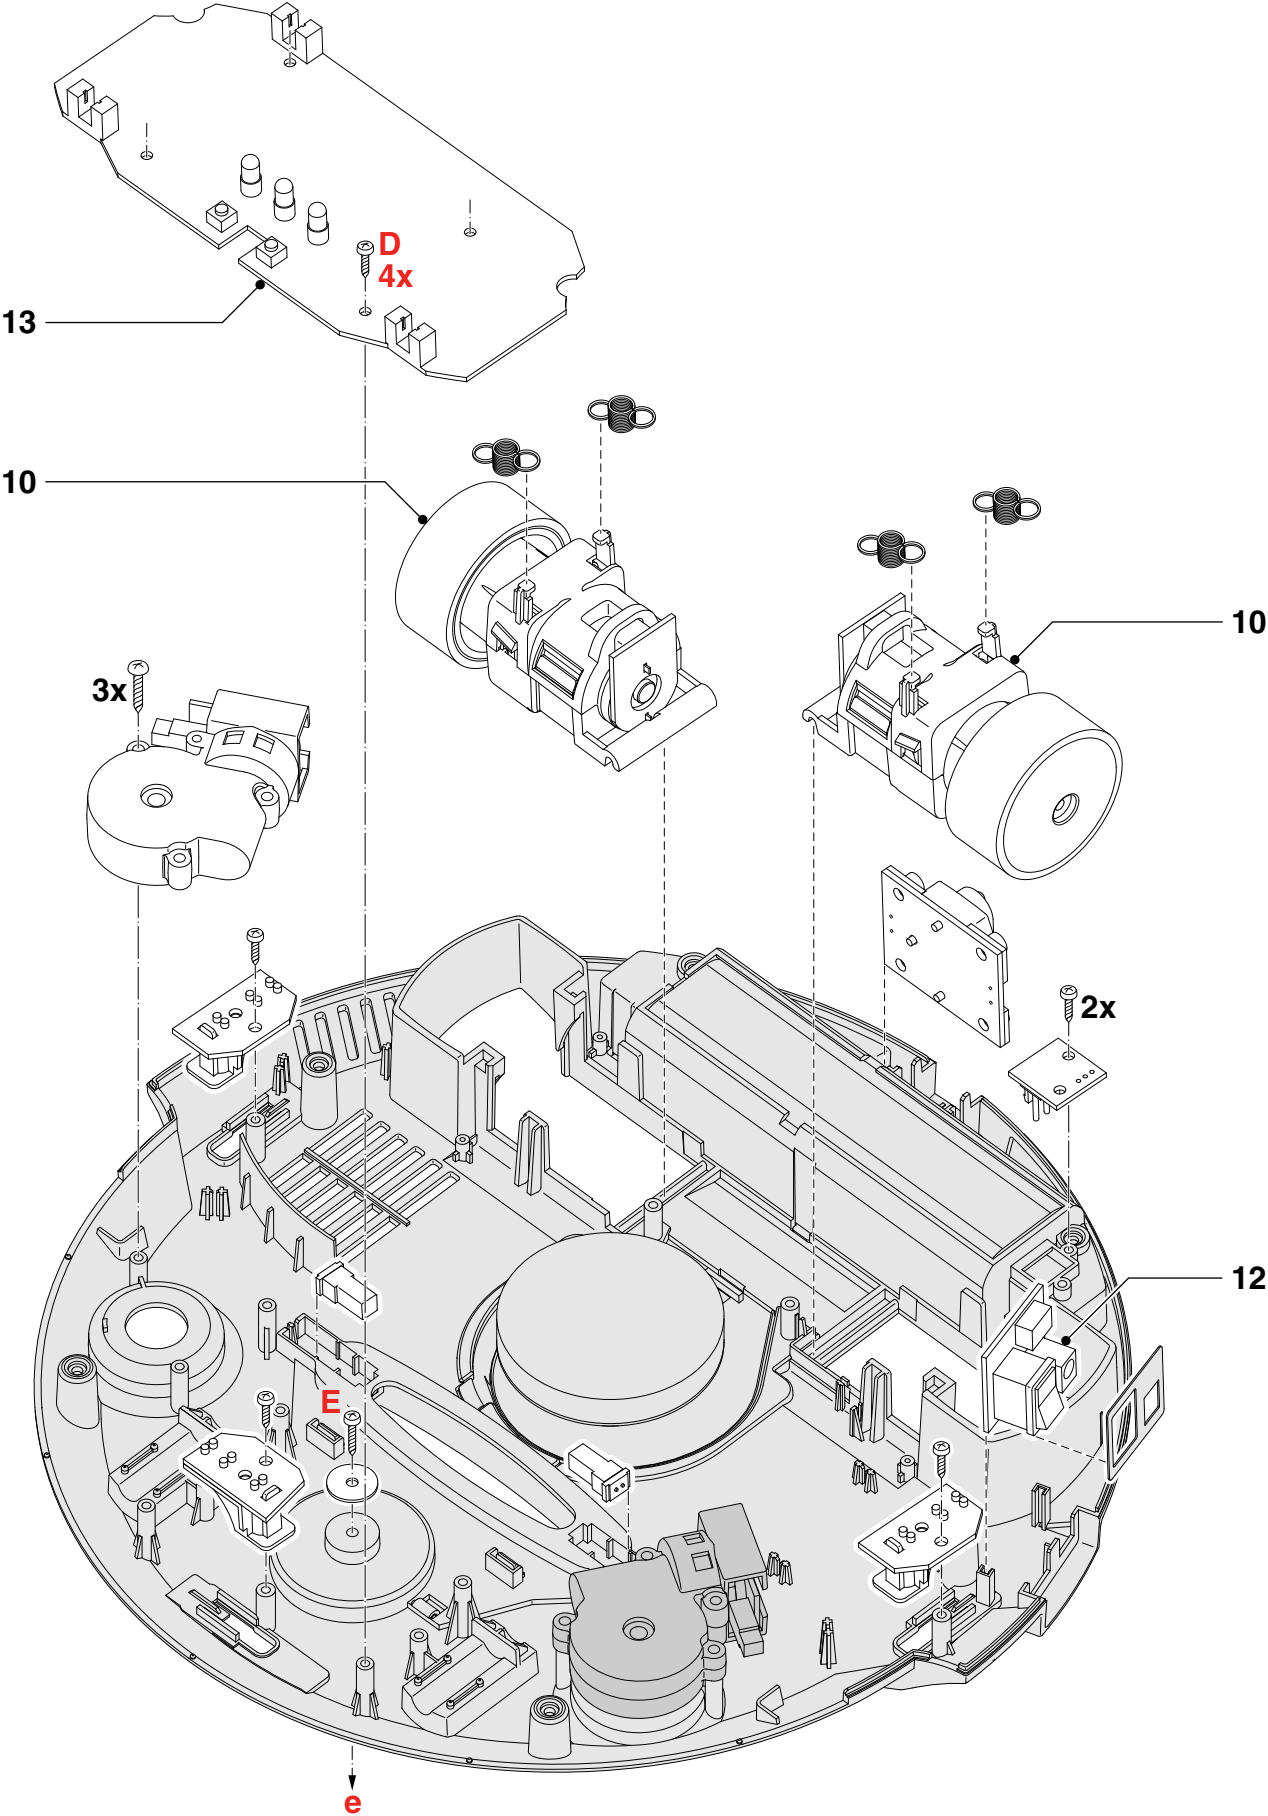
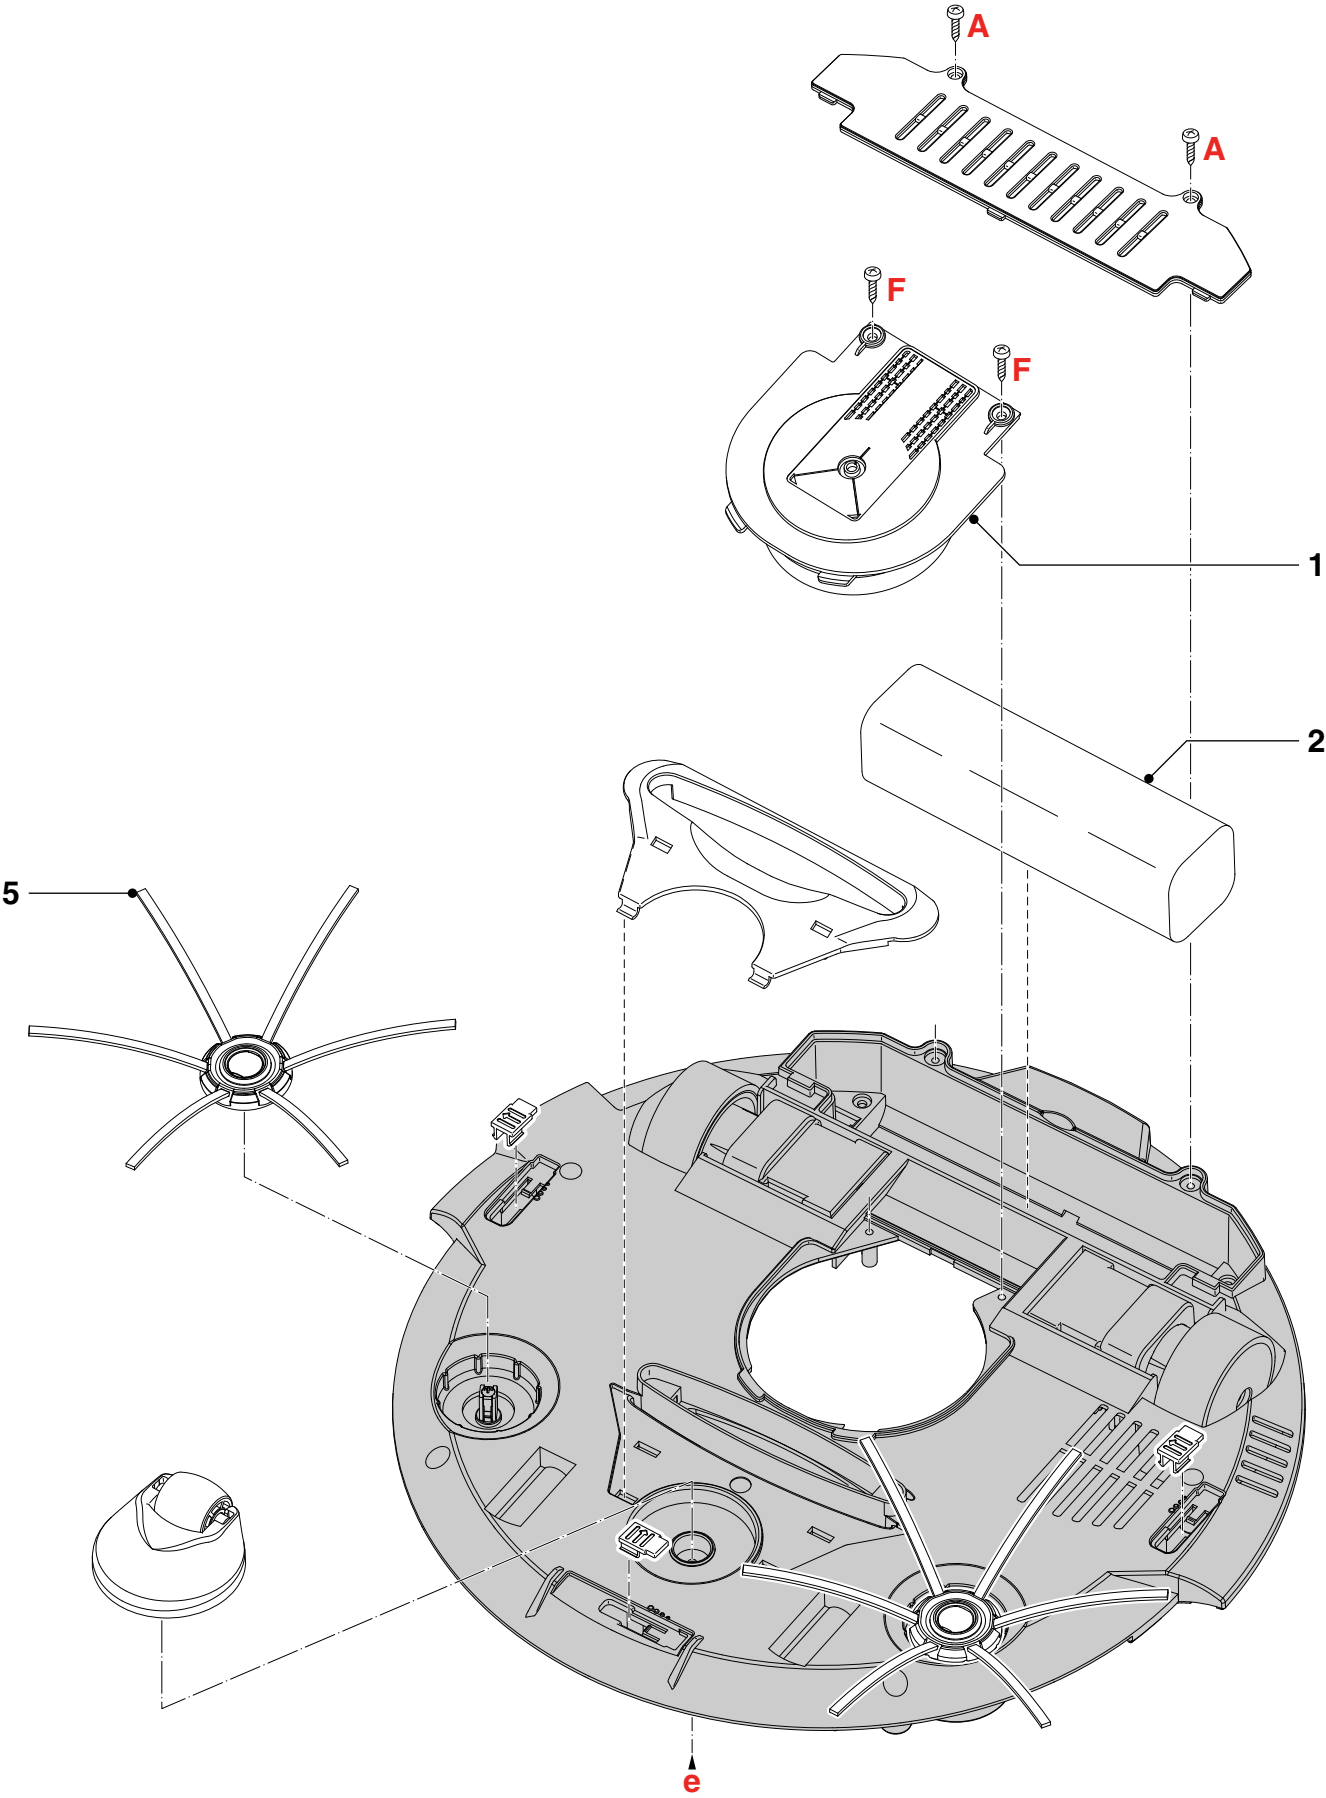
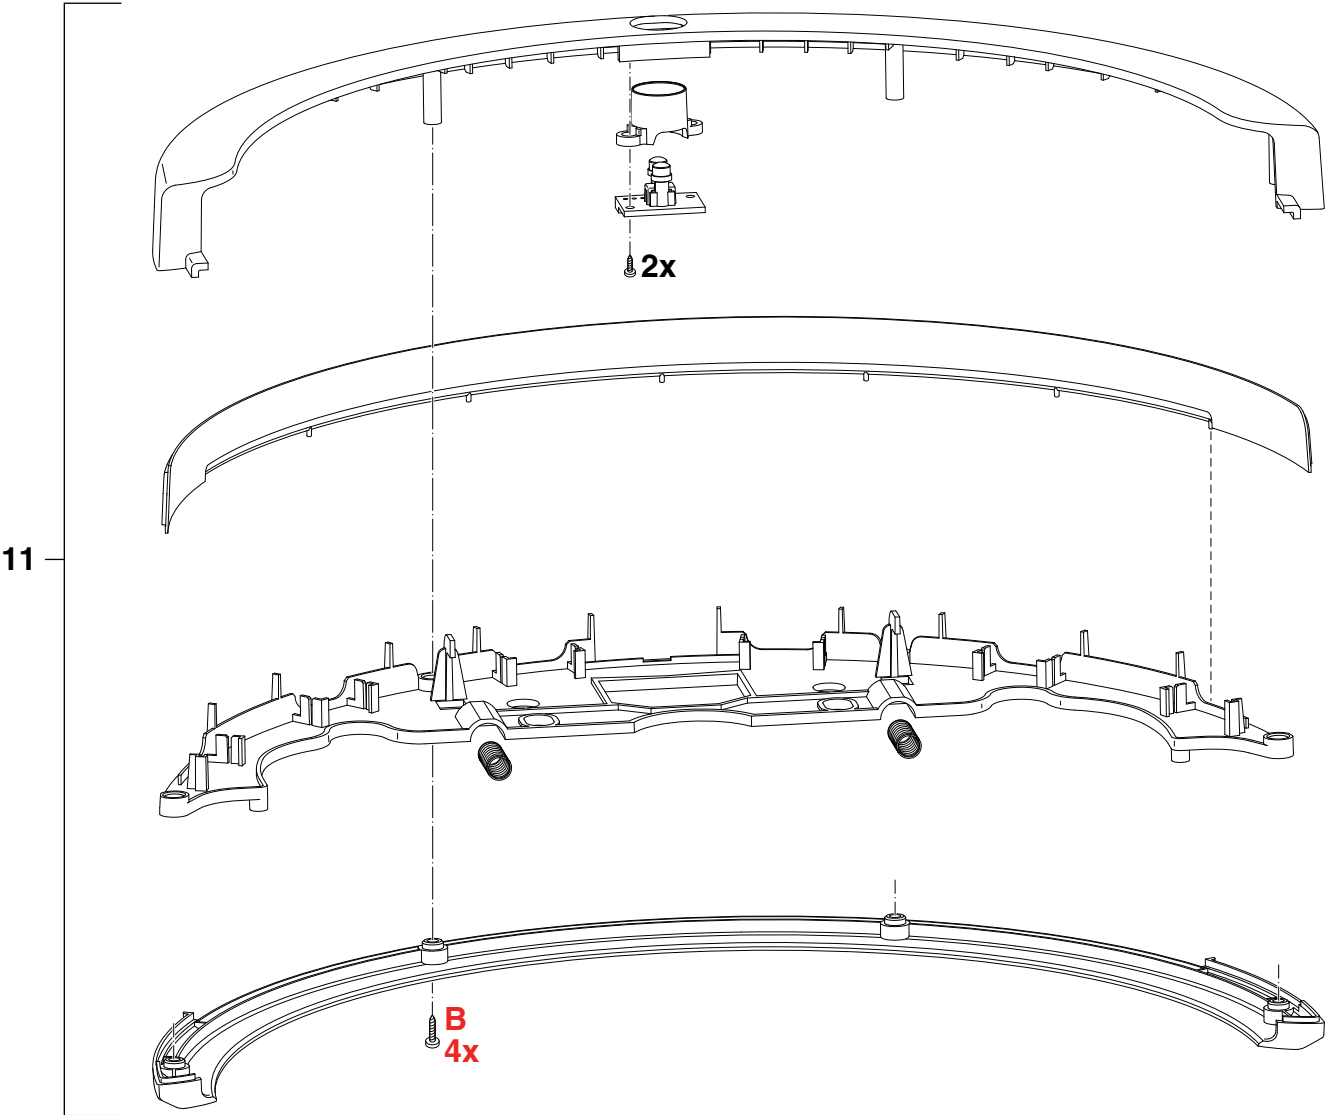
- Turn the appliance upside down .
- The brushes can easily be pulled out and replaced, after hearing the < click> the brush is placed in a correct way.

- Remove the battery cover by removing the 2 screws **A**, the battery can now be removed or replaced.
- To open the appliance:  
First remove the cover of the Bumper assy by removing the 4 screws **B**.  
Remove the Upper housing by removing the 6 screws **C**, 2 screws are positioned in the battery compartment, **be aware** to unplug the wire.

- Now the wheel can easily be pulled out and be replaced if necessary.  
Remark: notice that each wheel assy have different wires to avoid mis-repair.
- To replace the inner parts of the Bumper assy:  
Lift the Main PCB by removing the 4 screws **D**, now you can replace the Bumper bracket by removing the 2 screws.

- To replace the Fan motor:  
Turn the Bottom housing upside down and remove the 2 screws **F**, unplug the connector. Now the Fan motor can be replaced and re-connected.
