Philips Consumer Lifestyle

Service Manual

FC8700/01 / FC8700/71

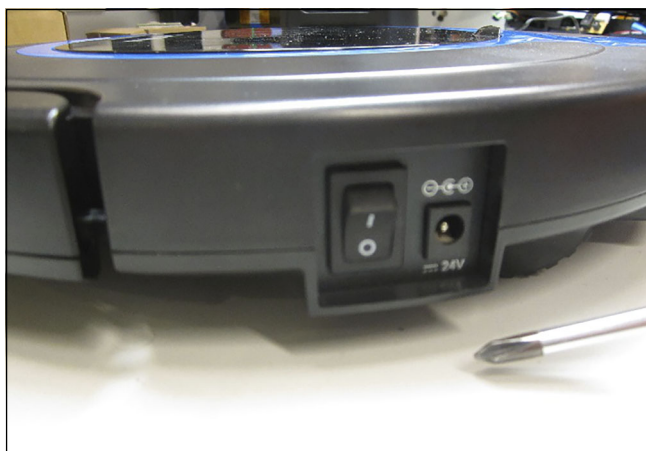
- Turn the appliance upside down.
Be sure that the appliance has been switched off.

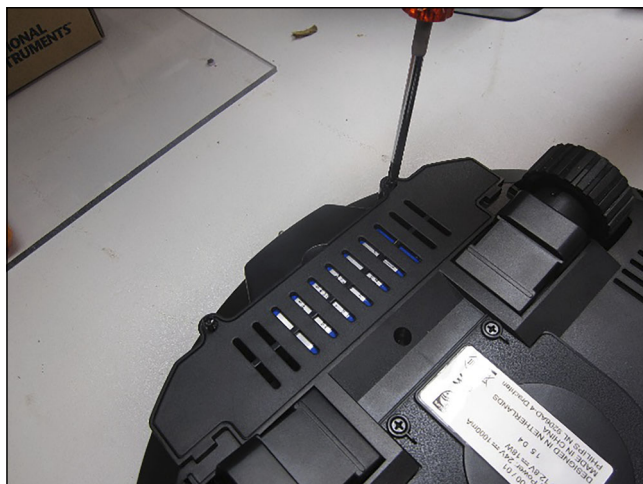
- Remove the battery cover by removing the 2 screws **A**.

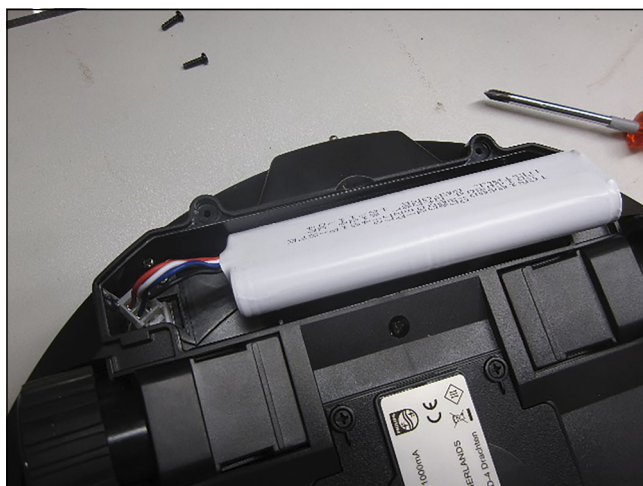
- The battery can now be removed by unplugging the connector and replaced.
(Colour of battery can be different).
Remark: The consumers are not allowed to change the battery themselves, it needs to be done by Repair Centers.

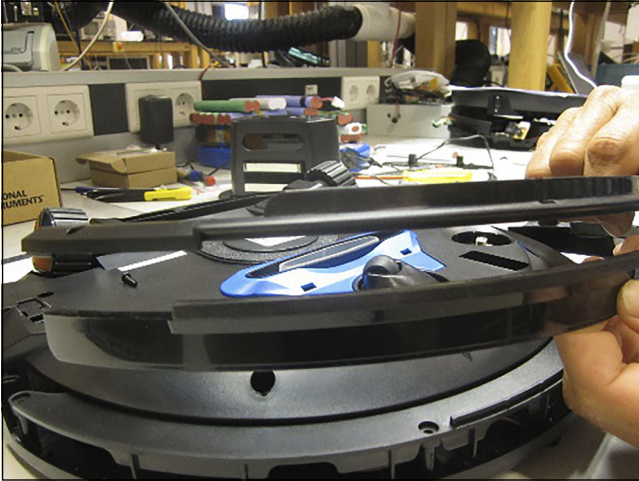
- Remove the cover of the Bumper assy by removing the 4 screws **B**. (The bumper consist out of 2 plastic parts).

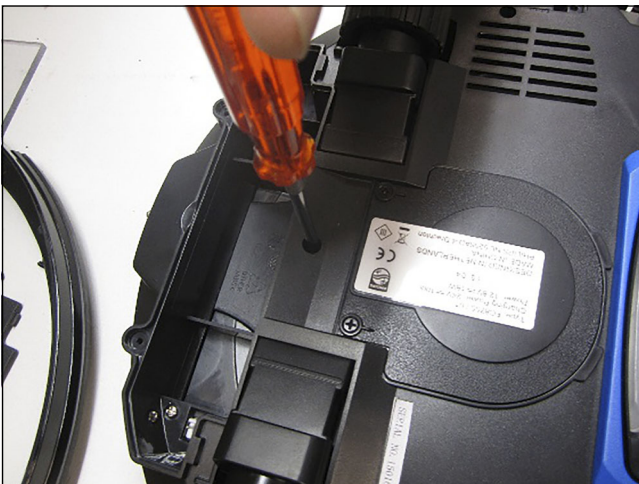
- Remove the Upperhousing by unscrewing the 7 screws
C, 2 screws are positioned in the Battery compartment,
 1 screw between the 2 wheels.

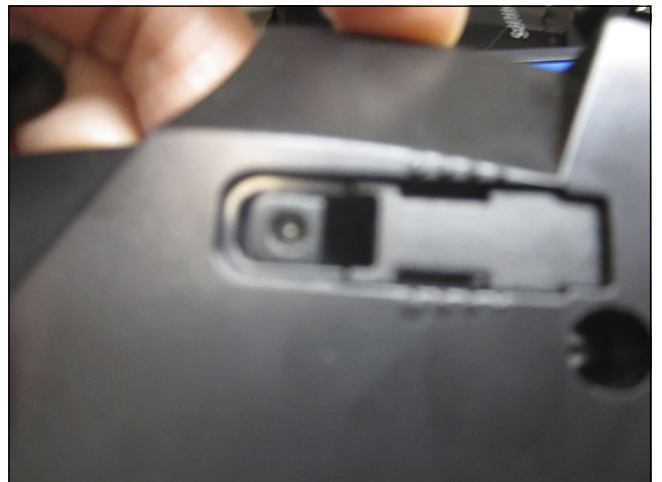
- While replacing the cliff Sensor be aware that it is positioned in the correct way, check if the wiring is correct and check by turning the bottom.

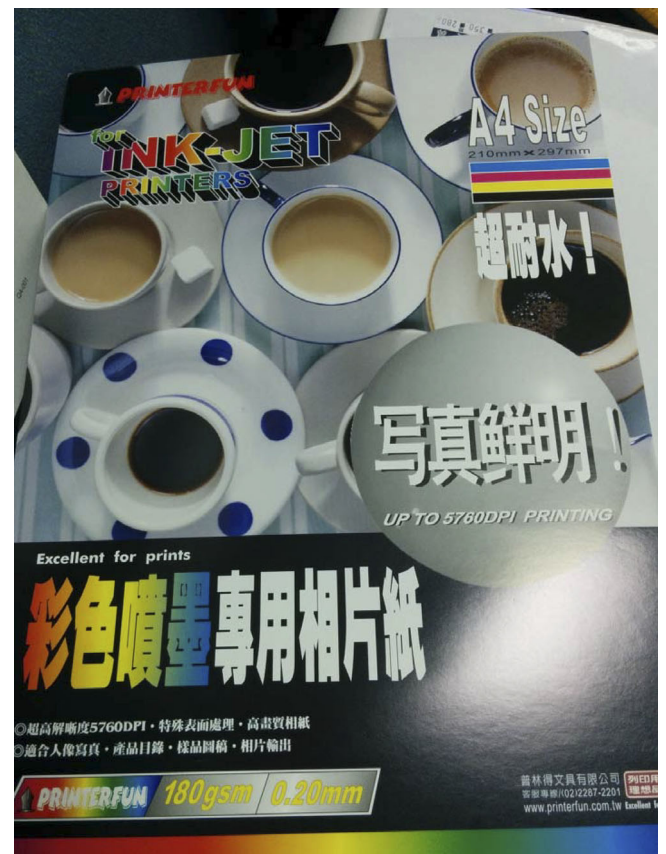
Material for white color reference:

Using AA white paper or glossy paper as calibration surface.
